**AGENDA**  
**LANDMARK COMMISSION**  
**REGULAR MEETING**  
**4:00 p.m. Monday, January 6, 2025**  
**City Council Chambers, 2<sup>nd</sup> Floor of City Hall**  
**823 Rosenberg, Galveston, Texas**

## MINUTES OF THE LANDMARK COMMISSION OF THE CITY OF GALVESTON REGULAR MEETING – December 16, 2024

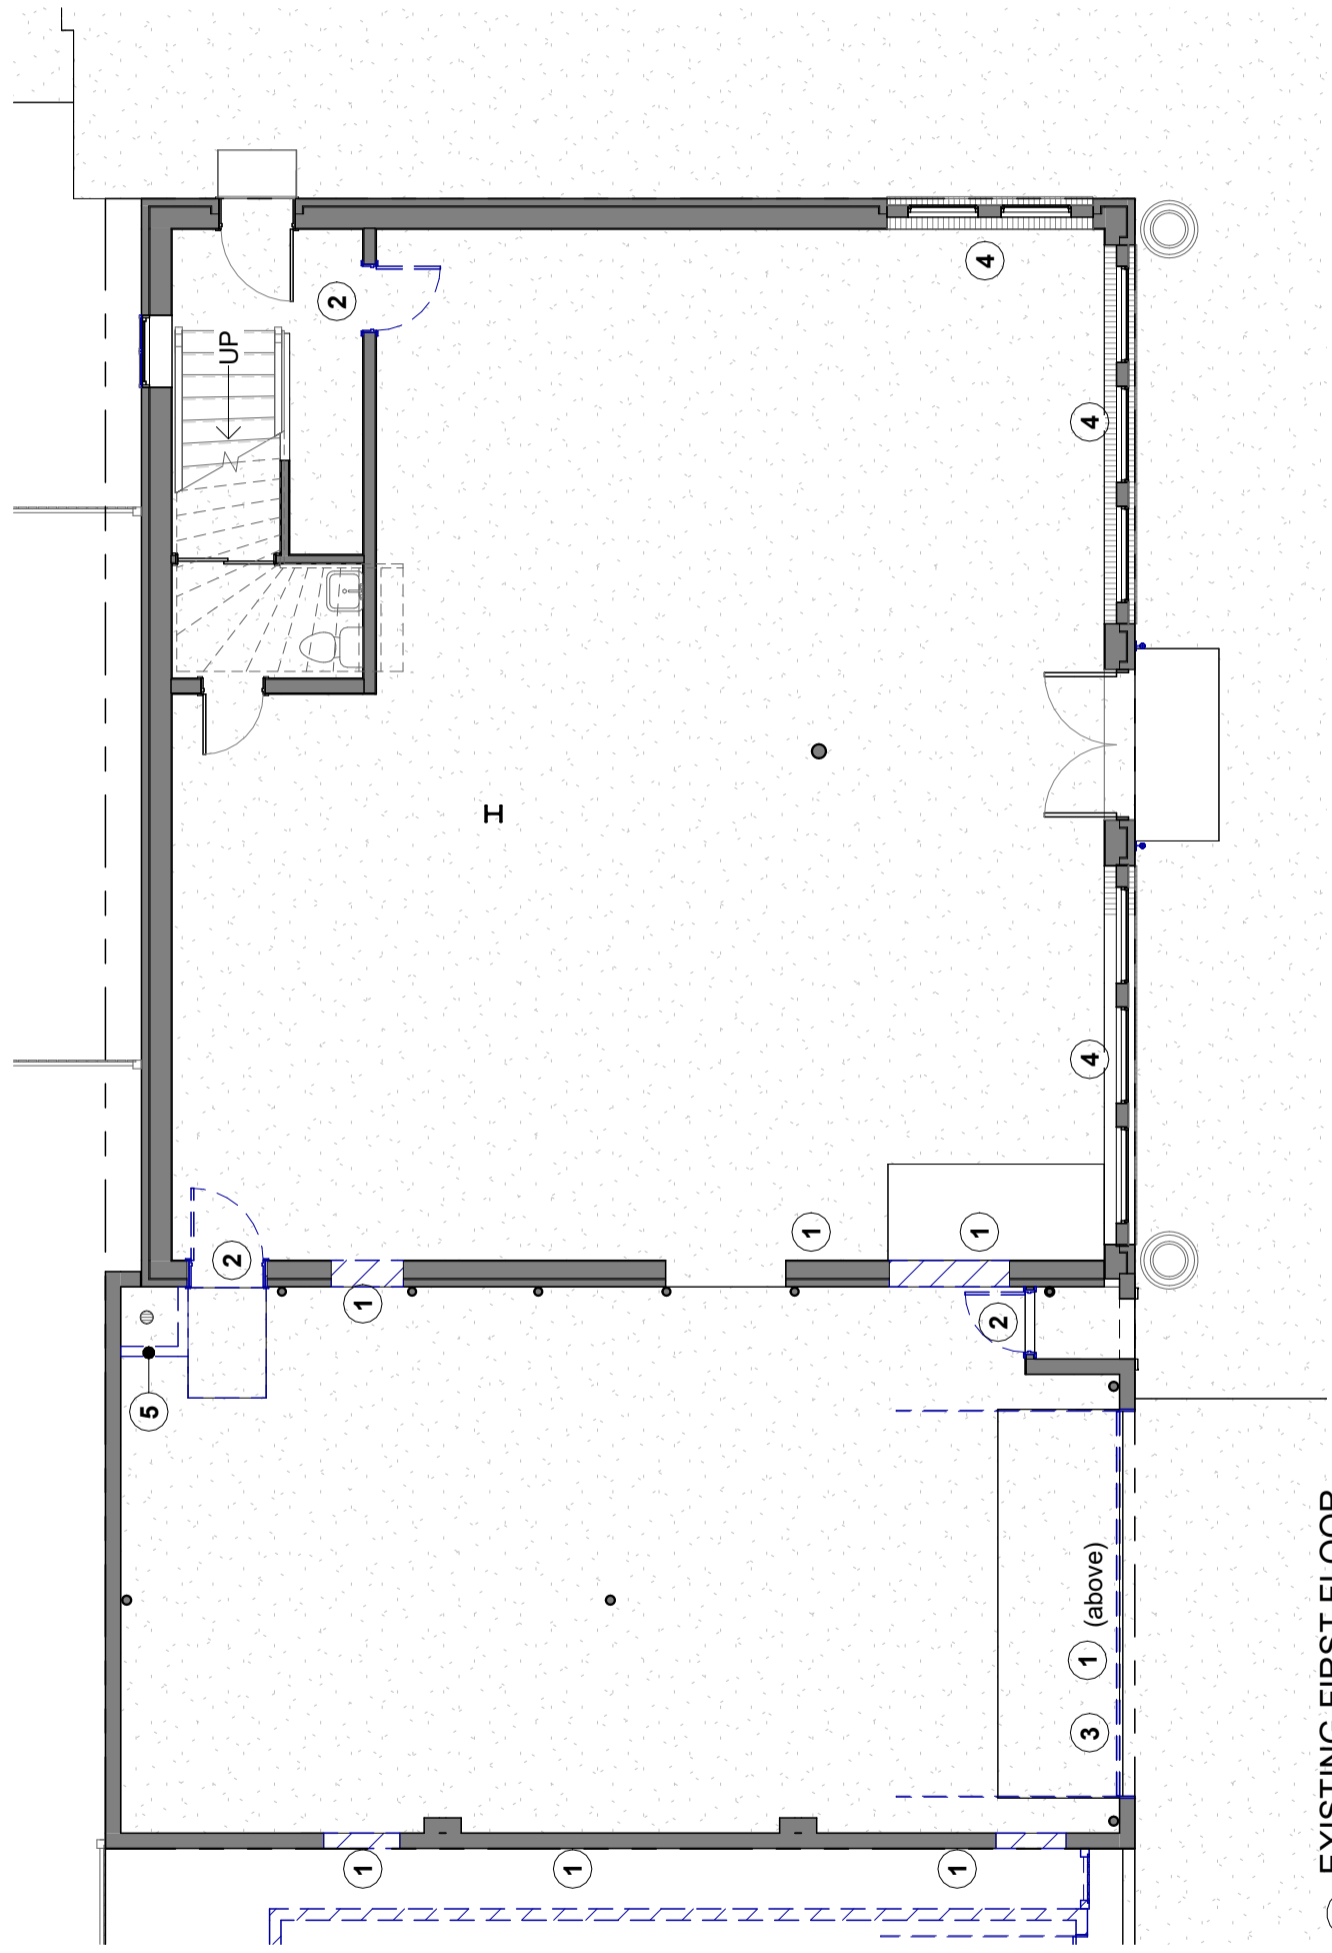
1 EXISTING FIRST FLOOR  
1/8" = 1'-0"

Demolition Keynote Legend	
Keynote	Definition
1	Demo for new opening
2	Remove door
3	Remove garage door
4	Remove interior trim
5	Demo concrete curb

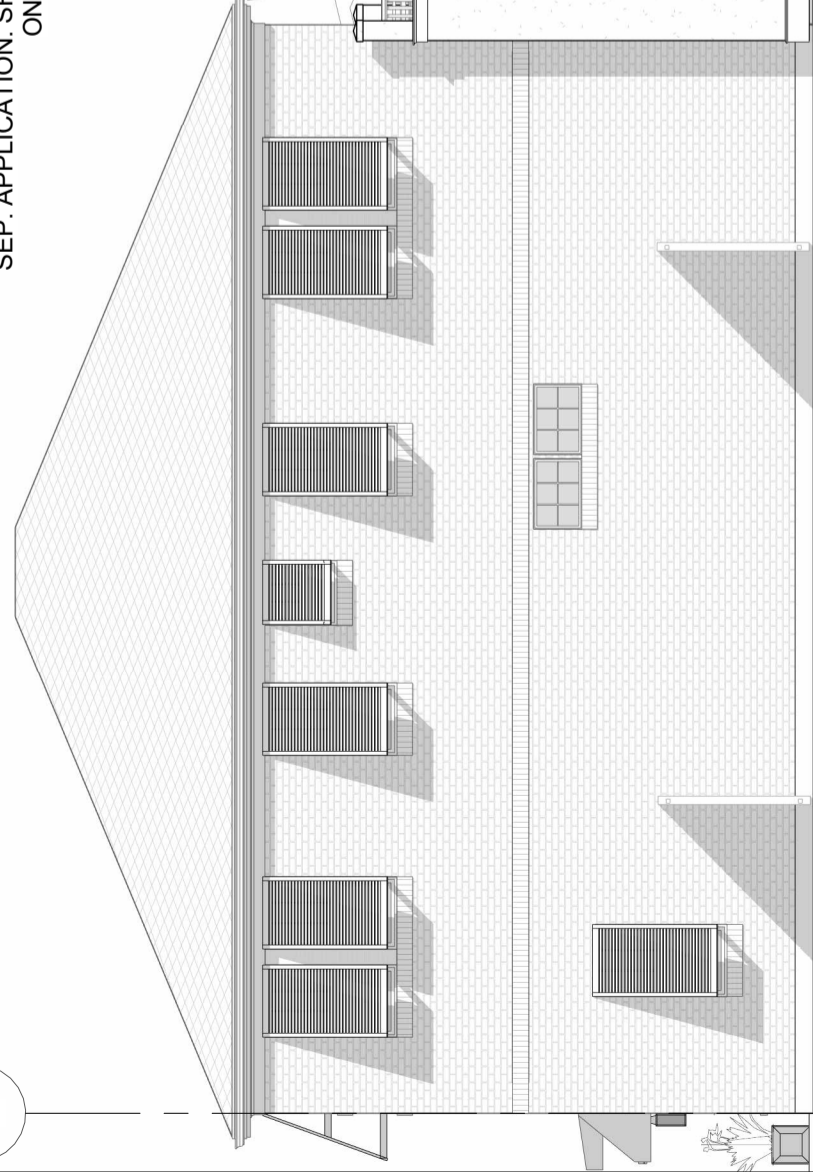
1 East  
1/8" = 1'-0"

RESTORE  
HISTORIC  
WOOD LOUVER  
SHUTTERS ON  
ALL WINDOWS
