19LC-033 STAFF REPORT

ADDRESS:
 1327 Ball/ Avenue H

REQUEST:
 The applicant is requesting a Certificate of Appropriateness in order rebuild the existing stairs and add new vertical balustrades.

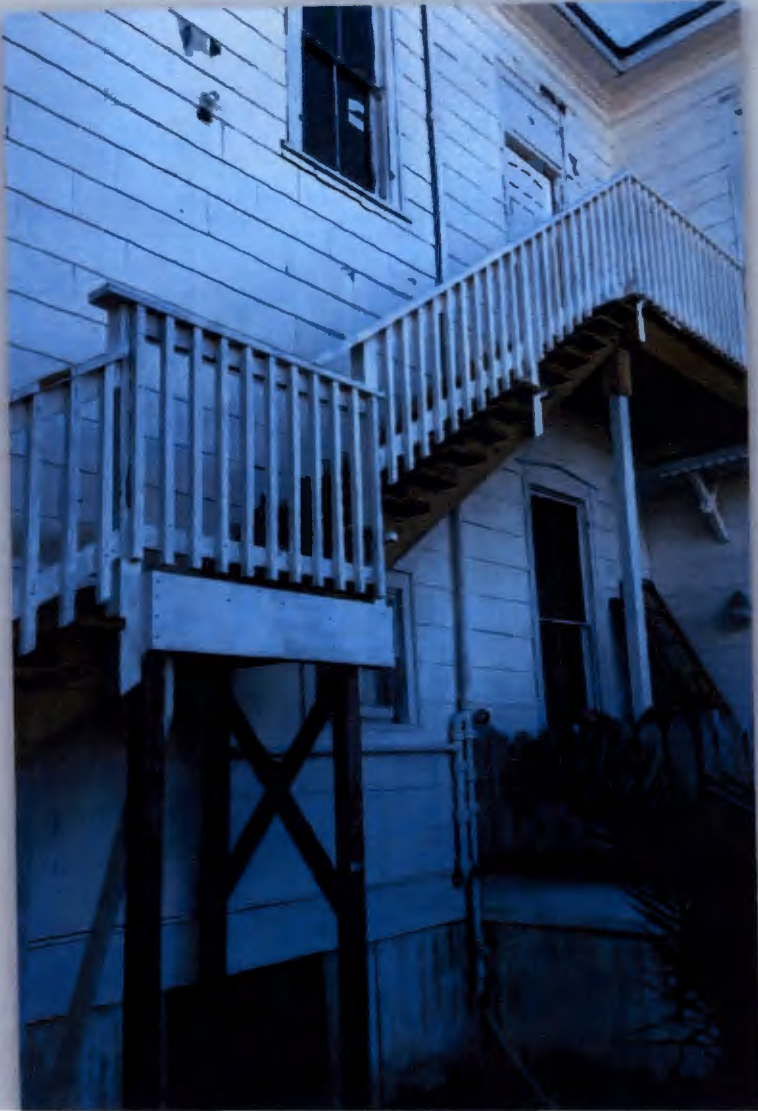
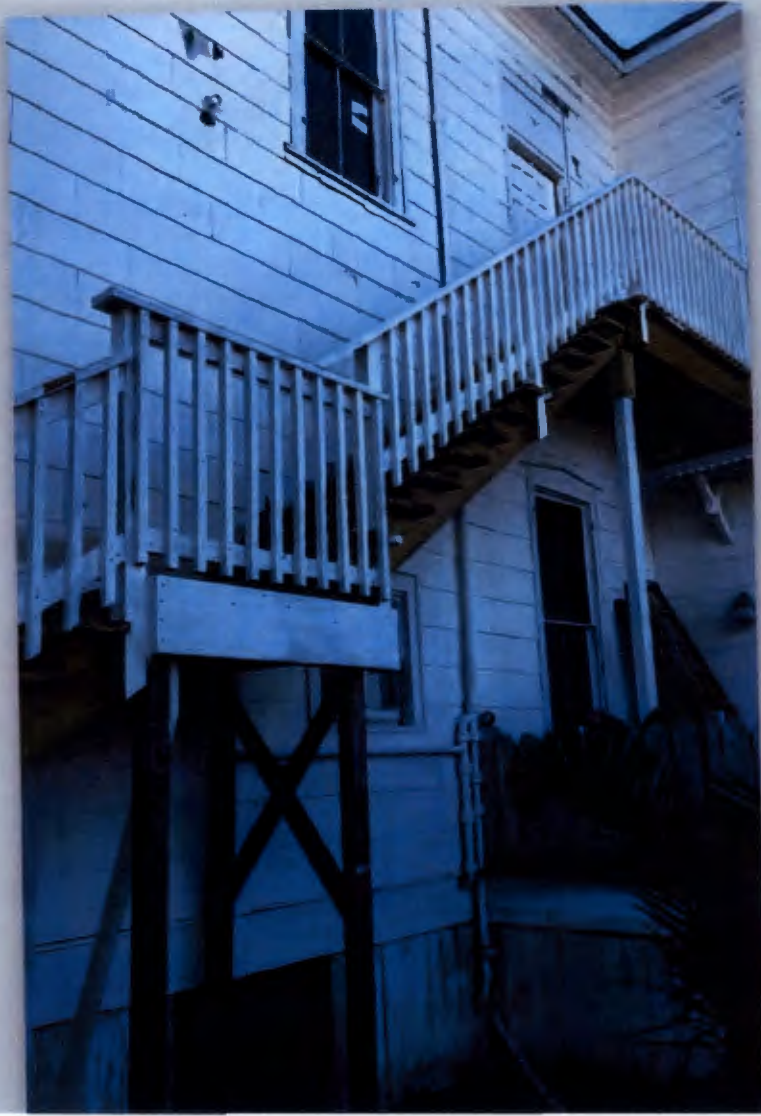
The stairs were in disrepair so the applicant repaired the stairs and added new railing without getting a permit. The applicant is requesting approval of a Certificate of Appropriateness in order to retain the side stairs and railing that has been constructed. The balustrades are square and set outside the railing. Please reference Exhibit B for the design of the newly constructed stairs.

The new landing and stairs are located in Location B: Highly visible secondary wall: Preservation and repair in place is the priority. According to a Sanborn Map dated 1899 the stairs are not original to the house. Since the stairs are not original to the structure, Staff finds the railing should be in a simple square design with the balusters set inside the railing. Please see Exhibit E for the standard railing design for use in historic districts.

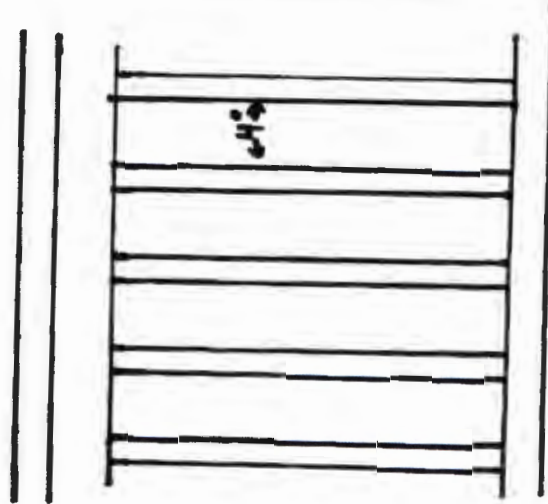
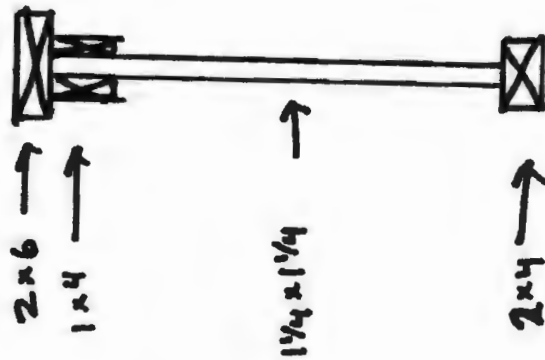
Typical City-approved historic rail design

Spacing between pickets is 4 inches on center. Gap from bottom of lower 2x4 rail to deck should be 3 inches.

1. The work shall conform to the design, materials, and placement shown in Exhibit C of the Staff Report, with the following modifications:
 - a. The stairs shall be painted to match the house;
 - b. The railing shall be modified to match the design shown in Exhibit E within
